**Flood Control Project Maintenance
Levee Inspections**
LMA District Cover Sheet
Spring 2017 Levee Inspection Results

Reclamation District No. 0563 Tyler Island

Unit Cover Sheet

| Waterway | | | Bank | Unit Miles |
|---|---|---|---|---|
| Unit No. 01 Georgiana Slough (Tyler Island) | | | Left | 12.11 |

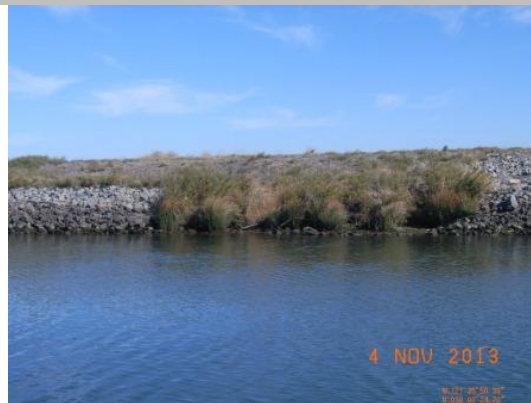
Photo 1 of 1 : SP_2017_RD0563_210_43_20170313_00036.jpg

| 1997 - Old damaged rock riprap along the toe. 1999 - Downstream end (400 ft) repaired with rock. 2002 - New rock/concrete rubble section on the downstream end. 2004 - Small pocket repairs at the downstream end. 2005 - Some new bundles in the brush boxes. 2012 - Some rock has been placed in last year. 2015: Last observed in 2013. [2015 Site ID: GEO_1-7_L] | | | | | |

USACE 2013 Photo #1

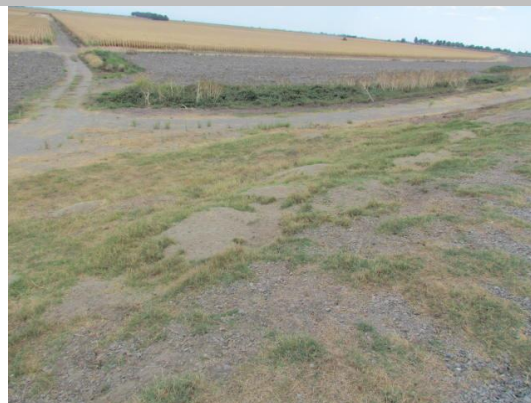
Photo 2 of 5 : SP_2017_RD0563_210_77_20170313_00069.jpg

| Several rodent holes and rodents noted at this site. | | | | | |

Looking southeast at several rodent holes on landward slope.

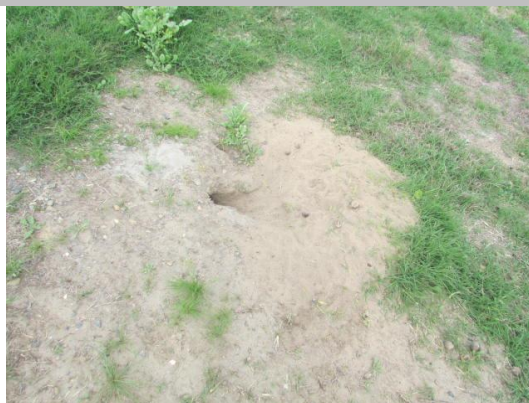
Photo 4 of 5 : SP_2017_RD0563_210_77_20170313_00071.jpg

| Several rodent holes and rodents noted at this site. | | | | | | |

Looking at typical rodent holes on landward slope.

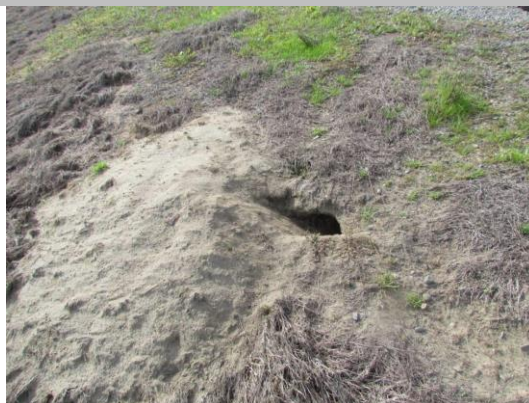
Photo 5 of 5 : SP_2017_RD0563_210_77_20170316_00261.jpg

Looking at typical rodent hole along this reach. (Spring 2017)

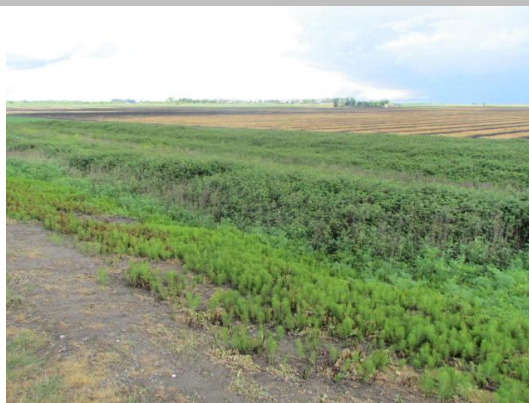
Photo 1 of 3 : SP_2017_RD0563_210_100_20170313_00102.jpg

| Wild rose or grape vines on landward slope and toe. | | | | | |

Looking northeast at dense vegetation at landward toe. (Spring 2015)

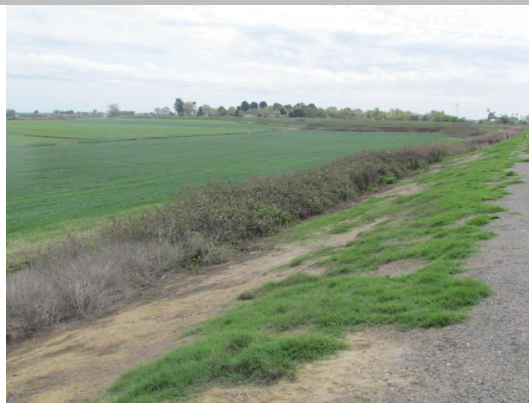
Photo 2 of 3 : SP_2017_RD0563_210_100_20170313_00103.jpg

Looking south at dense vegetation at landward toe. (Fall 2014)

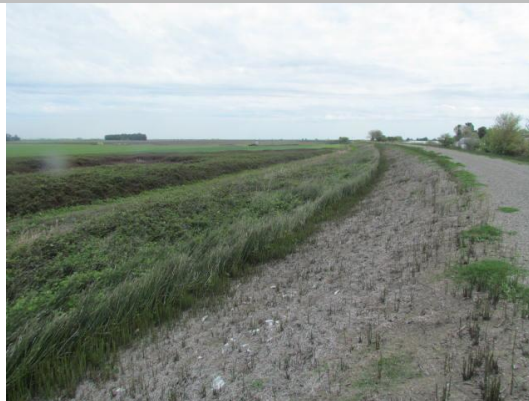
Photo 3 of 3 : SP_2017_RD0563_210_100_20170313_00104.jpg

| Wild rose or grape vines on landward slope and toe. | | | | | | |

Looking south at additional dense vegetation at landward toe.

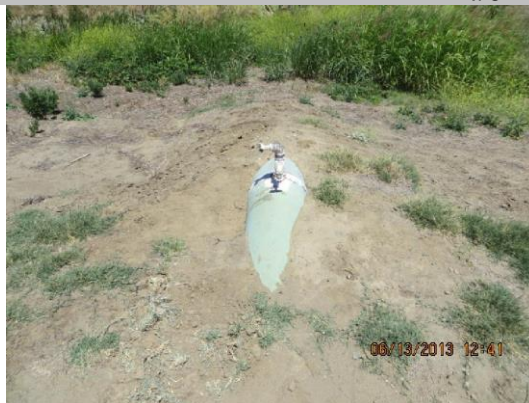
Photo 1 of 3 : UCIP_SP_2017_15002_24691.jpg

FS_ID:15002
DS_ID:20170
EP_NO: 11217
Repair Type: Non-Urgent
Crossing Status: Found
UCIP Comments: Pipe does not have appropriate clearance at Levee crown.
FIELD_STRUCT_DESC: 9 of 11: 16-inch steel irrigation siphon pipe through the levee 1-foot below the crown. Air vent/filler pipe on LS shoulder. Slide gate in 5-foot diameter steel standpipe on LS toe (ABO No. 11217, 1971). Originally included in the 1954 O&M manual.
FS Date: 6/13/2013

Vent/filler on pipe at LS shoulder.

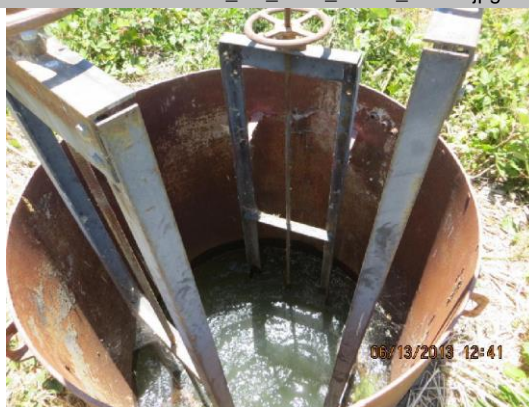
Photo 2 of 3 : UCIP_SP_2017_15002_24690.jpg

slide gate in steel riser on LS toe.

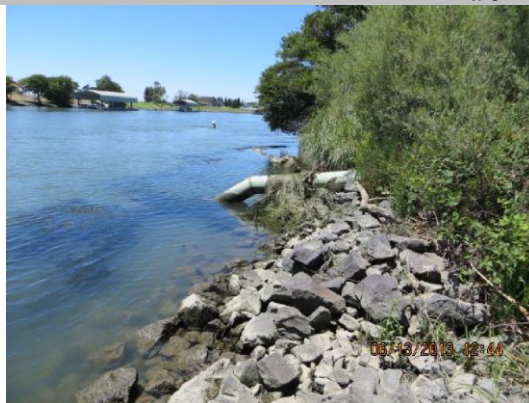
Photo 3 of 3 : UCIP_SP_2017_15002_24689.jpg

Pipe visible on WS toe.

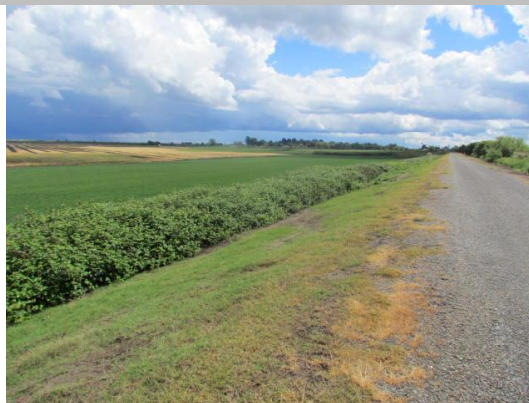
Photo 2 of 2 : SP_2017_RD0563_210_770_20170313_00154.jpg

| Dead dense veg (wildroses) at landward toe. | | | | | | |

Looking southeast at dense vegetation at landward toe. (Spring 2015)

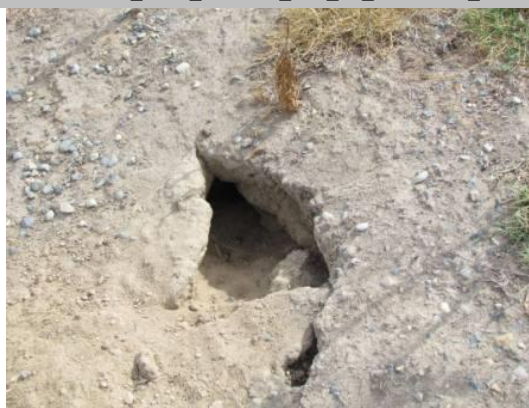
Photo 1 of 3 : SP_2017_RD0563_210_91_20170313_00092.jpg

Looking east at rodent hole on landside slope.

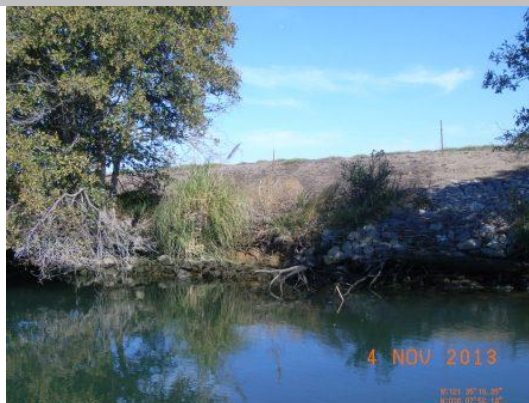
Photo 1 of 1 : SP_2017_RD0563_210_42_20170313_00035.jpg

| 1997 - Erosion pockets into the levee toe. 1999 - Some small pockets fixed with rock riprap. 2002 - New "brush boxes" along the bank toe. 2005 - Brush boxes are empty. Some pockets are filled with new stone. 2006 - Some new rock at the downstream end (~100 ft long). Several small pockets of new rock in scallops. Brush boxes in poor to fair condition. 2010 - Site looks a little worse, some toe rock but still has erosion scars at lower to mid slope. 2011 - Site upgraded to CRITICAL. Significant new erosion. Erosion scallops are vertical and almost the height of the levee. 2012 - Rock has been placed in some of the erosion scallops and therefore the site is no longer critical. 2013 - Site shortened site. The downstream half of site was repaired by RD. Pipe no longer in site limits. 2015: Last observed in 2013. [2015 Site ID: GEO_0-3_L] | | | | | |

USACE 2013 Photo #1

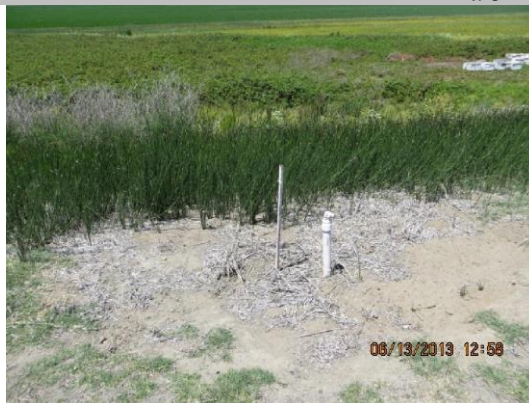
Photo 1 of 3 : UCIP_SP_2017_15004_24705.jpg

Vent and distribution box visible on LS.

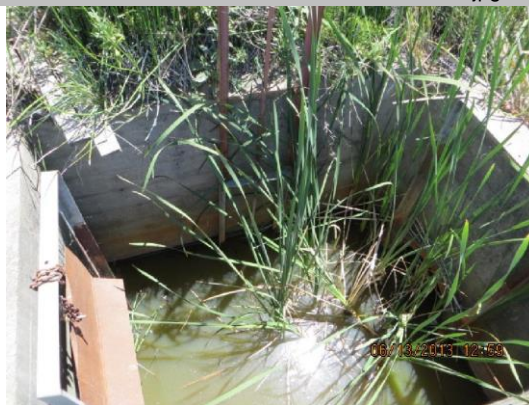
Photo 2 of 3 : UCIP_SP_2017_15004_24704.jpg

Distribution box and slide gate visible on LS toe.

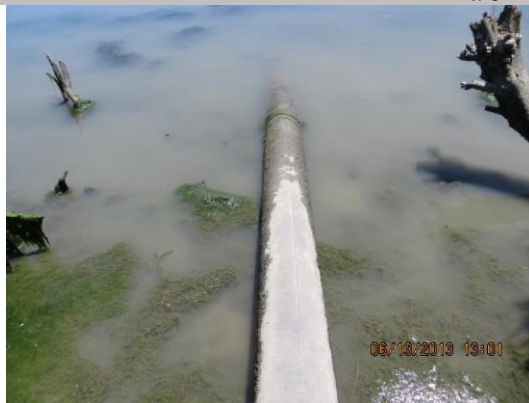
Photo 3 of 3 : UCIP_SP_2017_15004_24703.jpg

Pipe visible on WS toe.

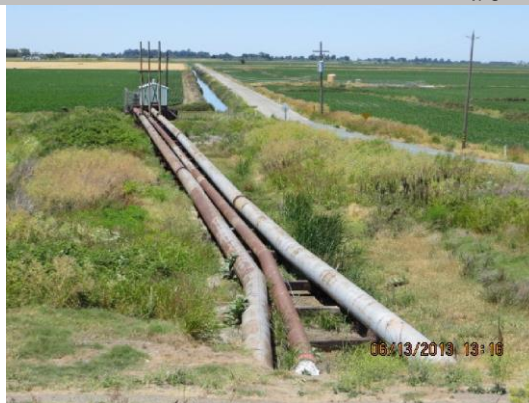
Photo 1 of 3 : UCIP_SP_2017_15027_24731.jpg

Pump and pipes off LS toe.

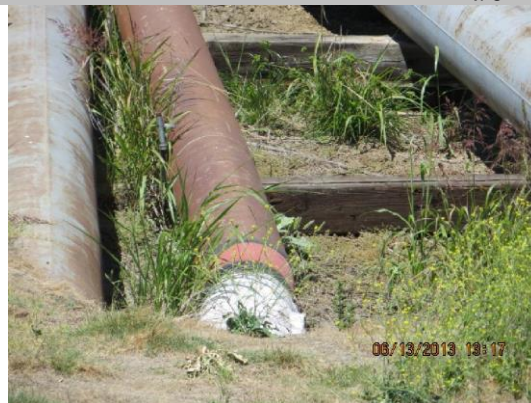
Photo 2 of 3 : UCIP_SP_2017_15027_24730.jpg

20-inch pipe on LS toe.

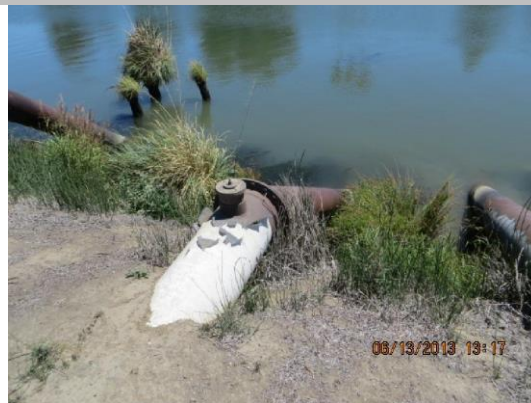
Photo 3 of 3 : UCIP_SP_2017_15027_24729.jpg

Pipe and siphon breaker on WS shoulder.

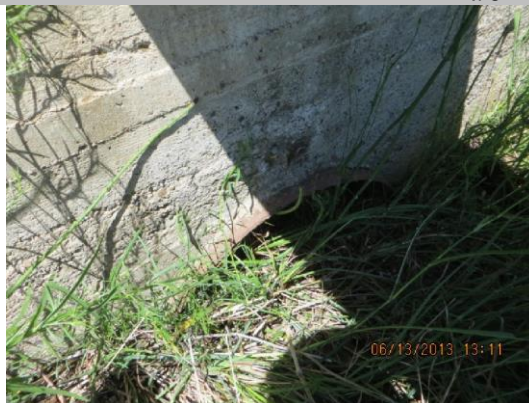
Photo 1 of 2 : UCIP_SP_2017_15028_24736.jpg

Pipe at concrete headwall on WS slope.

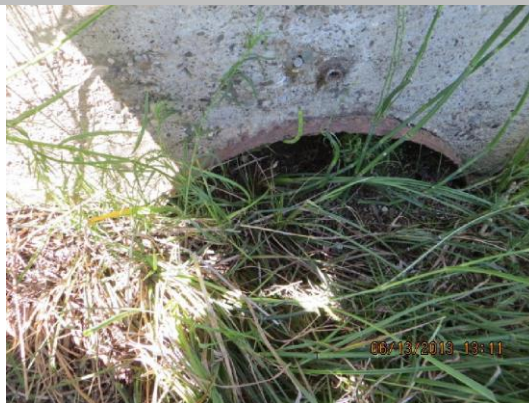
Photo 2 of 2 : UCIP_SP_2017_15028_24735.jpg

Pipe at concrete headwall on WS slope.

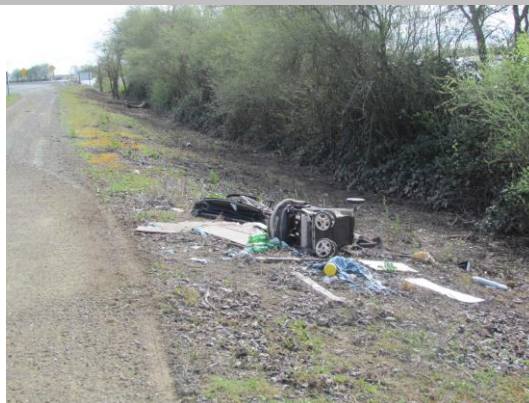
Photo 1 of 1 : SP_2017_RD0563_210_107_20170316_00263.jpg

| Garbage on waterward shoulder. | | | | | |

Looking southeast at garbage on waterward shoulder and slope.

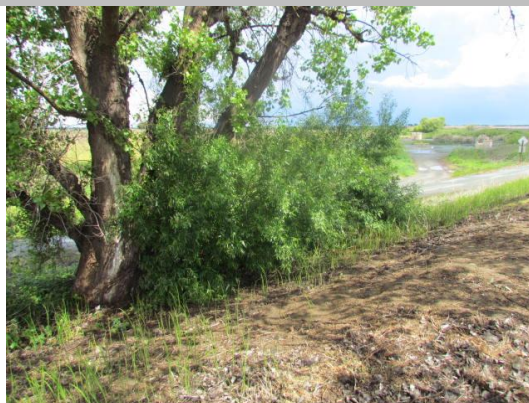
Photo 1 of 1 : SP_2017_RD0563_210_47_20170313_00040.jpg

Looking east at untrimmed tree at landward slope. (Spring 2015)
